**Informal Dispute Resolution
Presentation
By
Fields Brook Action Group
To
U.S. Environmental Protection Agency

Regarding
Detrex – Fields Brook DNAPL Issues

May 31, 2006
Cleveland, Ohio**

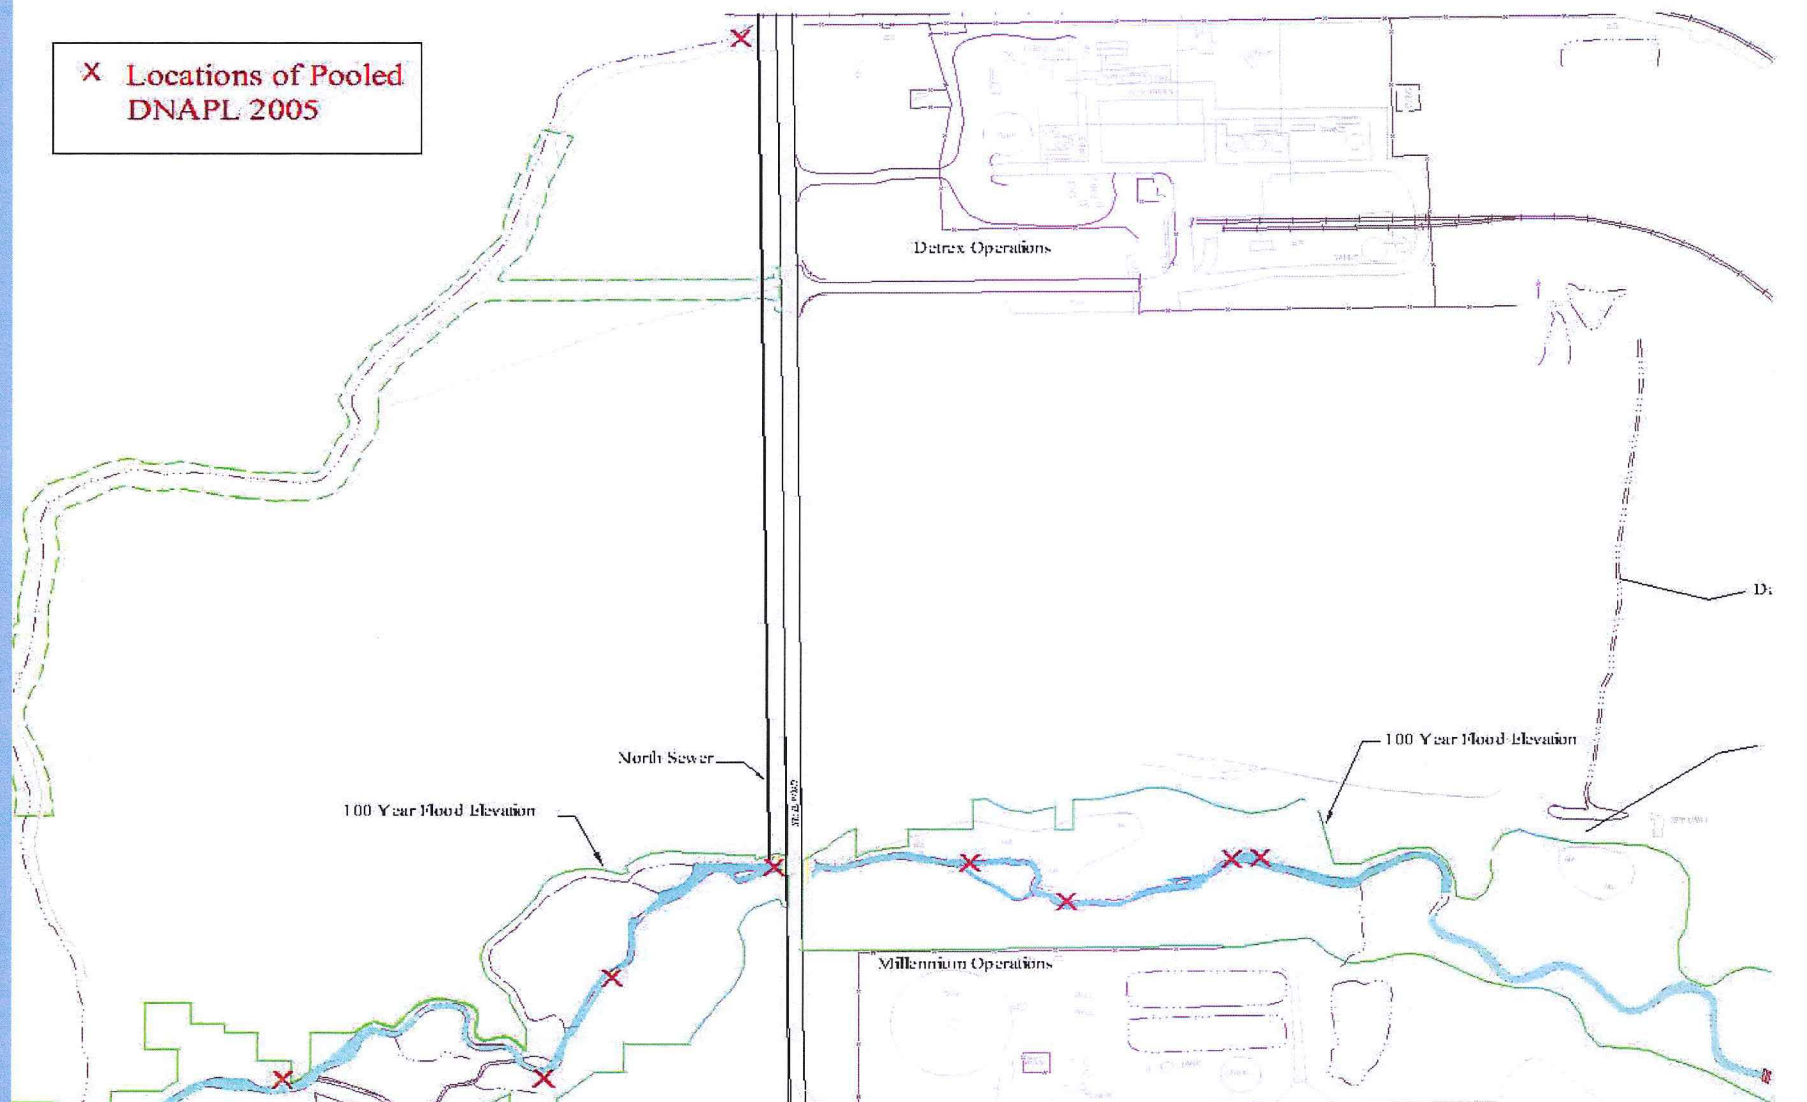
2005 DNAPL Study Findings

- **9 locations of pooled (mobile) DNAPL in EUs 8, 6 and 5, including**
 - **Surficial pooled DNAPL at the base of the State Road Sewer and DS Tributary (as it crosses State Road)**
 - **DNAPL chemically consistent with the material removed in 2001 that originated from Detrex facility**

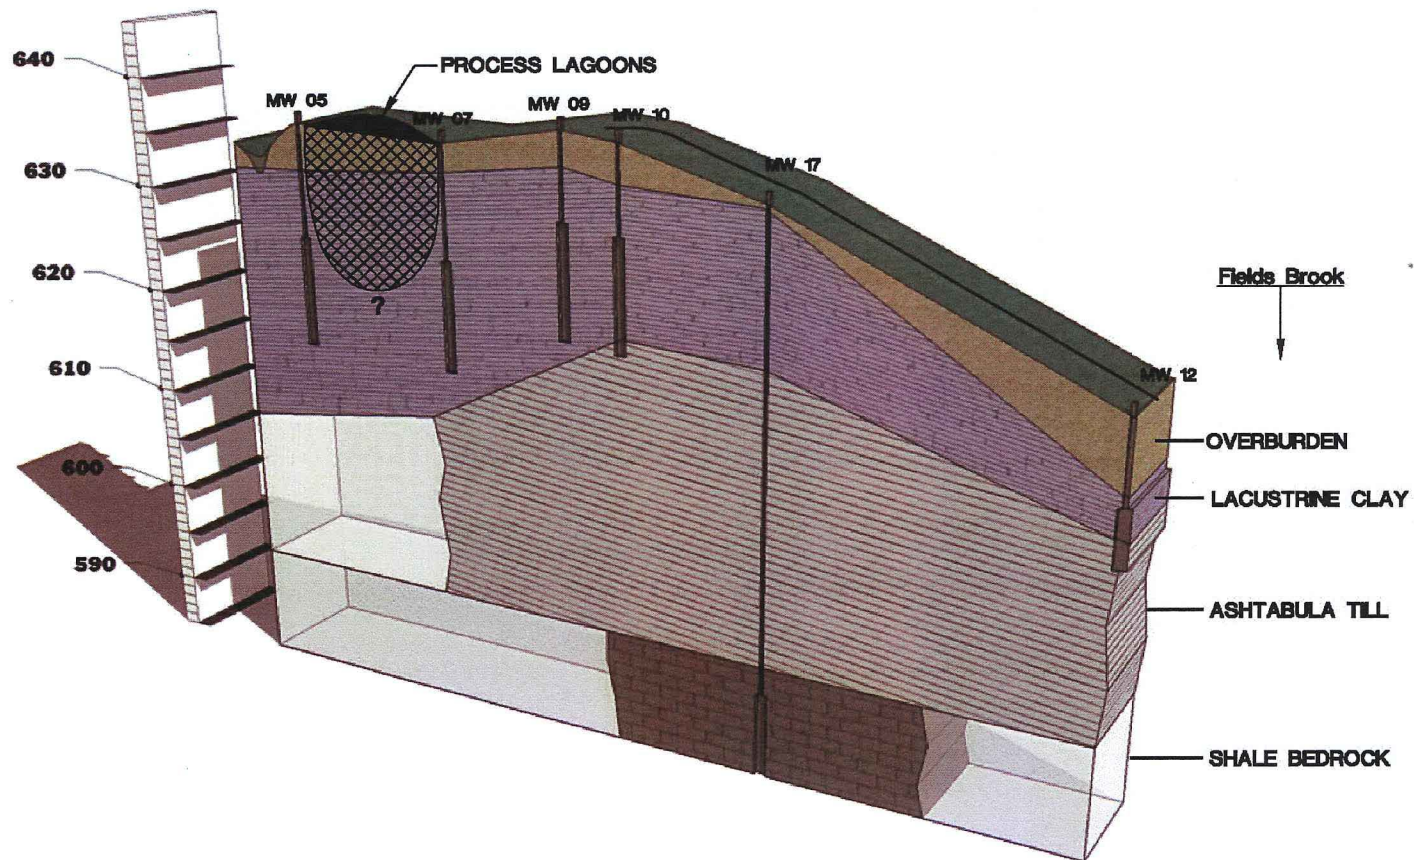
Geologic Cross-Section

**DETREX DEPICTION
OF THE GEOLOGY
WAS INCORRECT AND
NOT SUPPORTED BY
THE DATA**

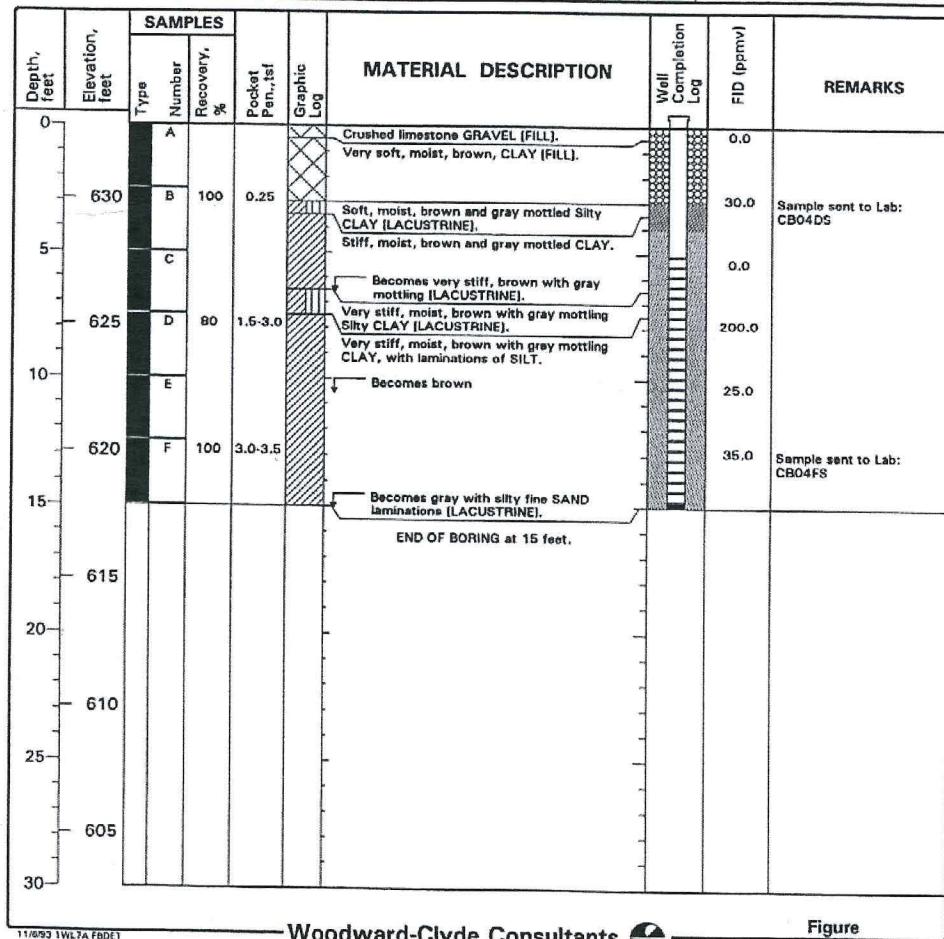
Log of Boring DETMW04S
 Sheet 1 of 1

Surface elevation = 632.9 ft

Depth of Boring = 15 ft

Bottom of hole
 elevation = 617.9 ft

Elevation used on Detrex map
 was 5 ft below bottom elevation,
 id est, 612.9 ft

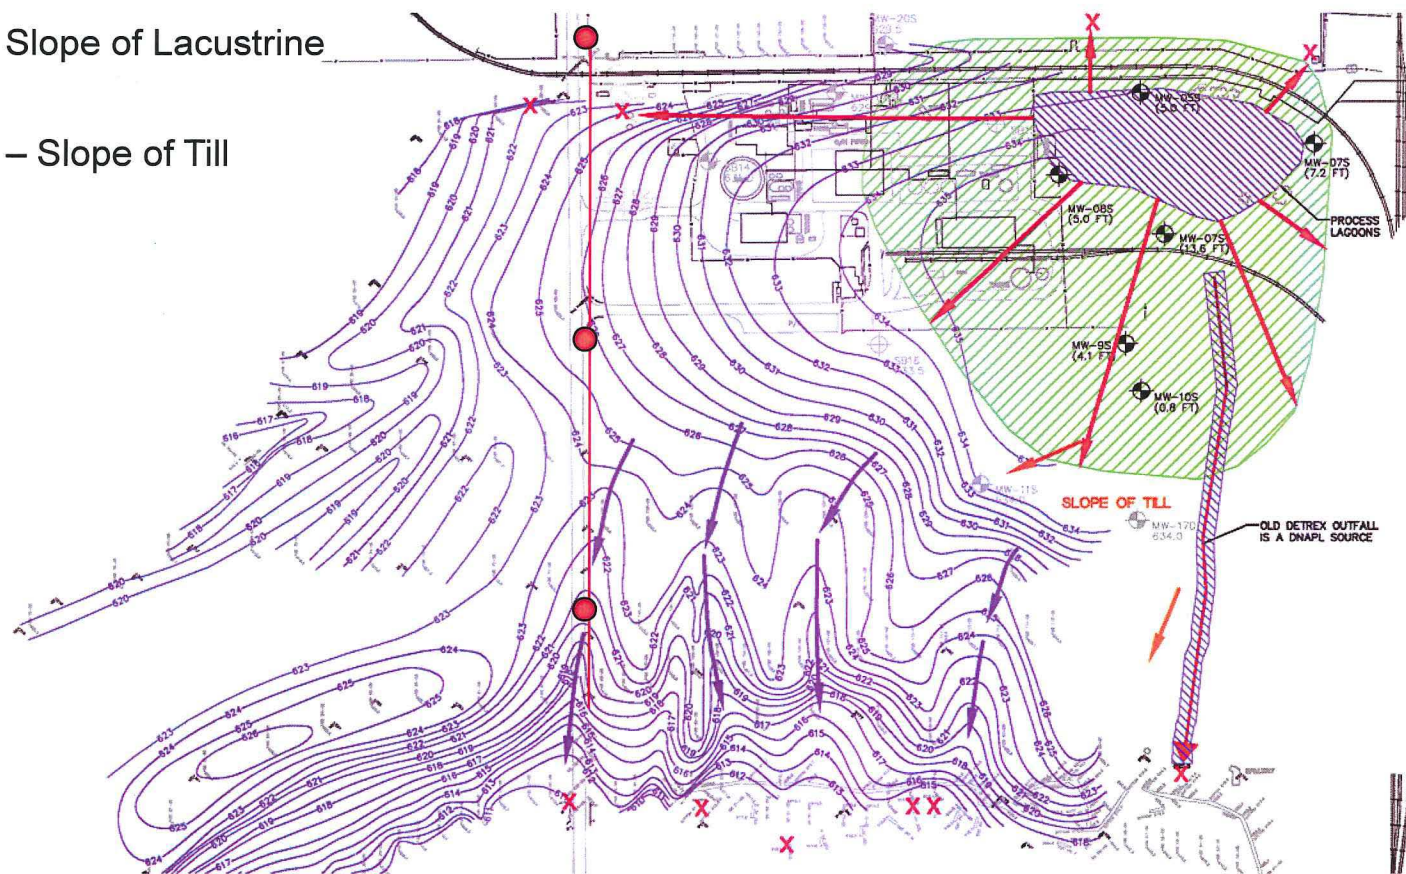
DNAPL Migration From the Detrex Source Area to Fields Brook

- **DNAPL migrates on top of the lacustrine clay and through the clay.**
- **DNAPL migrates on top of the till and through the till layer.**

DNAPL MIGRATION INTO THE LACUSTRINE CLAY

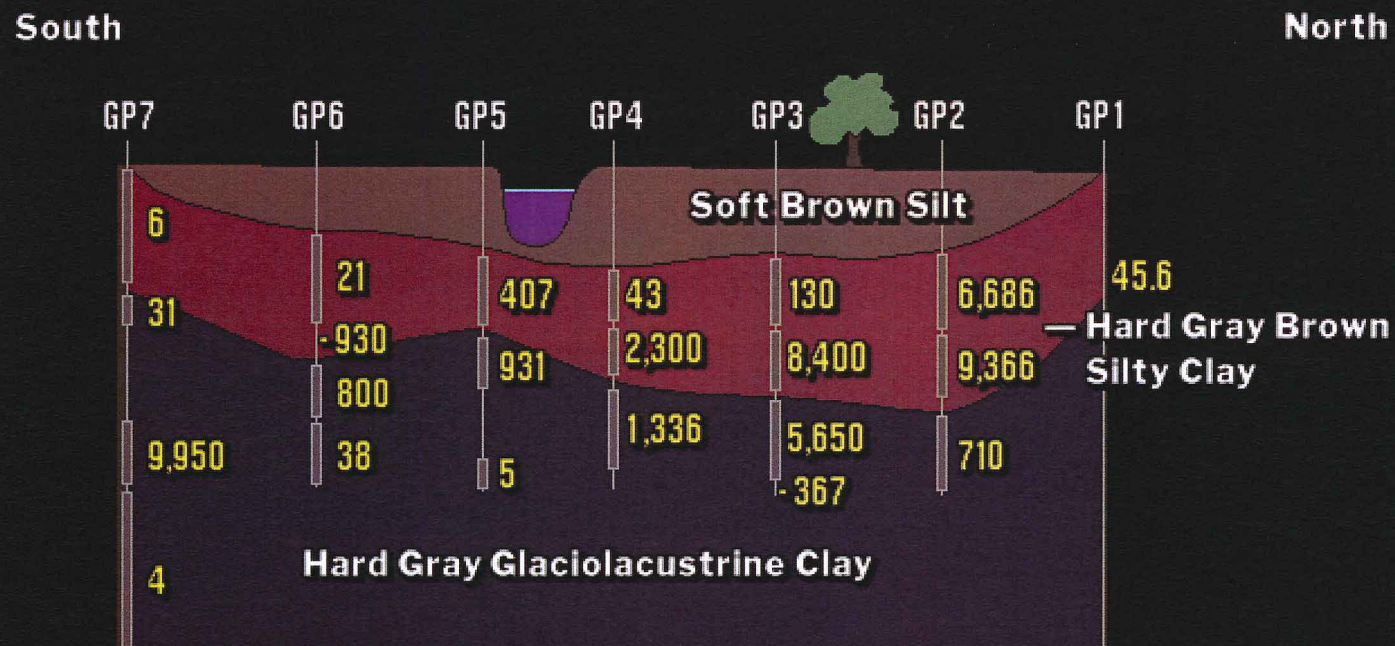
Cross Section

Geo-Probes: P.I.D. values in ppm

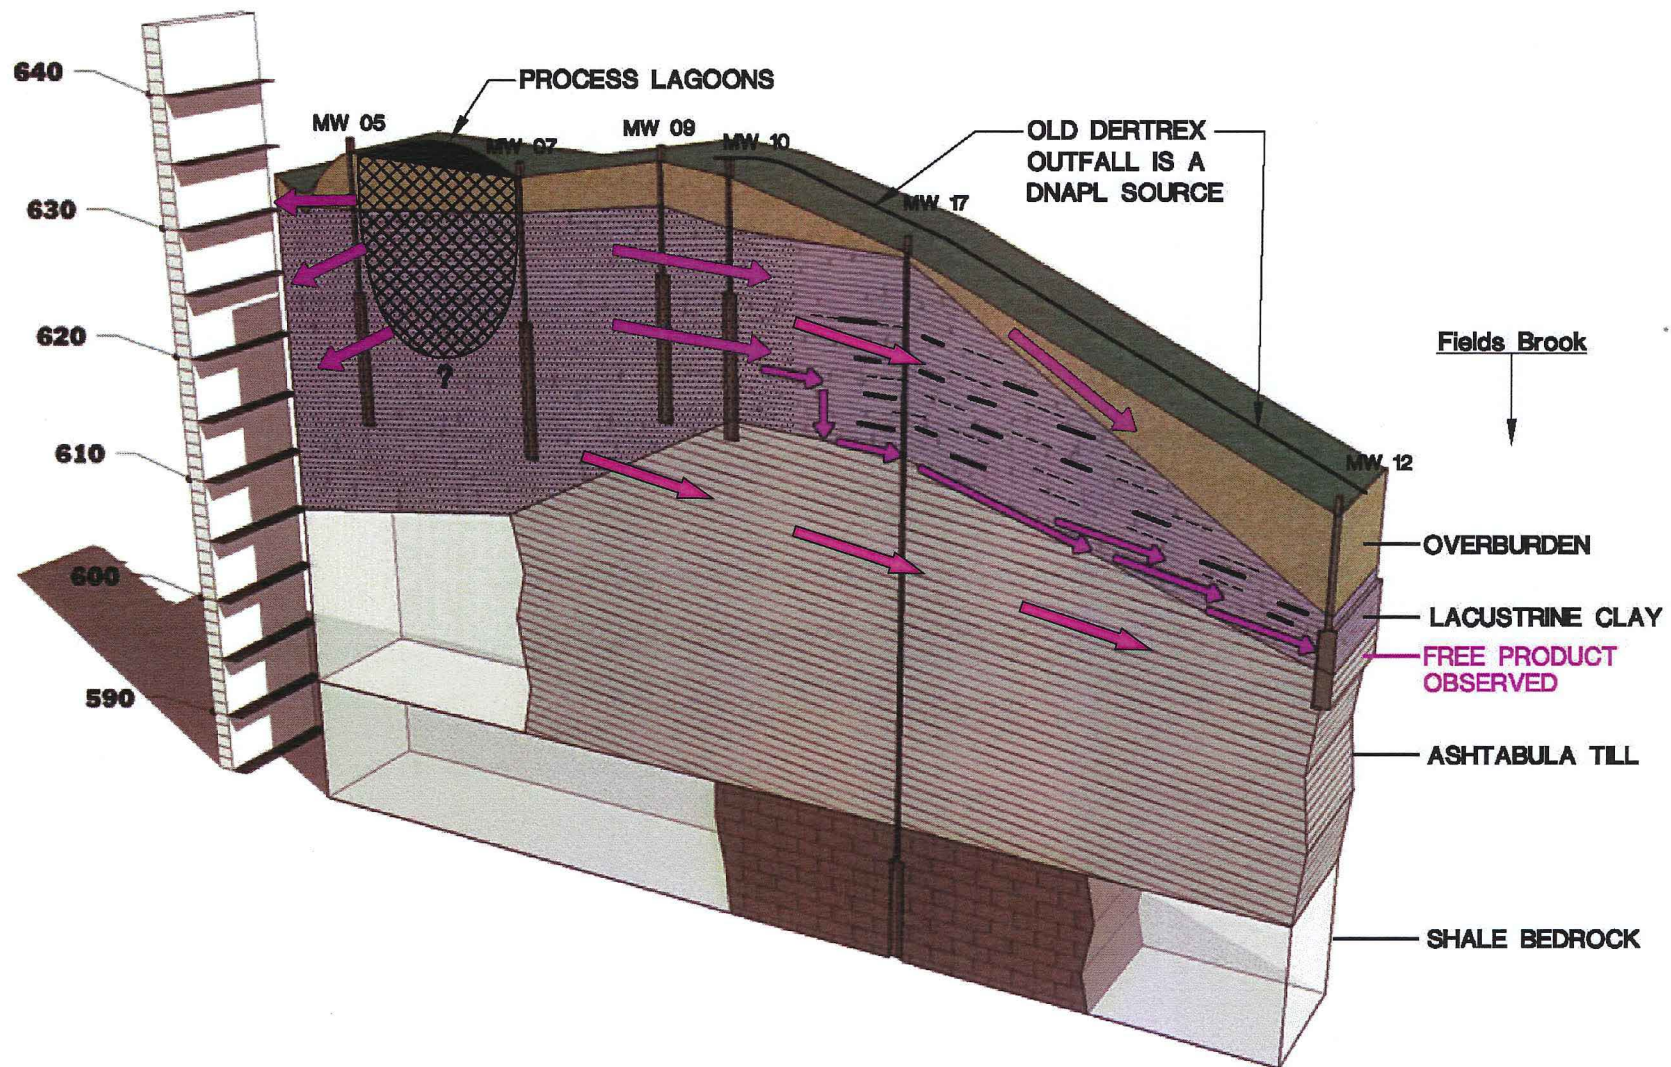
DNAPL Migration From the Detrex Source Area to Fields Brook

- **The Geologic Site Model used by Detrex was incorrect – DNAPL migration to Fields Brook is continuing**
- **The map of the DNAPL “plume” submitted by Detrex to U.S. EPA did not encompass the entire DNAPL source area**
- **The slurry wall was installed in the wrong location, and DNAPL migration to the DS Tributary continues**
- **There is no source control between the DNAPL source area and Fields Brook, and DNAPL migration to Fields Brook continues**

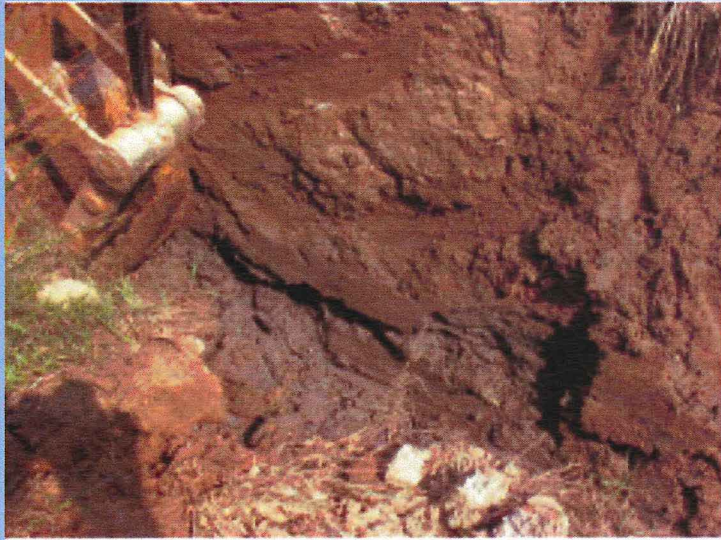
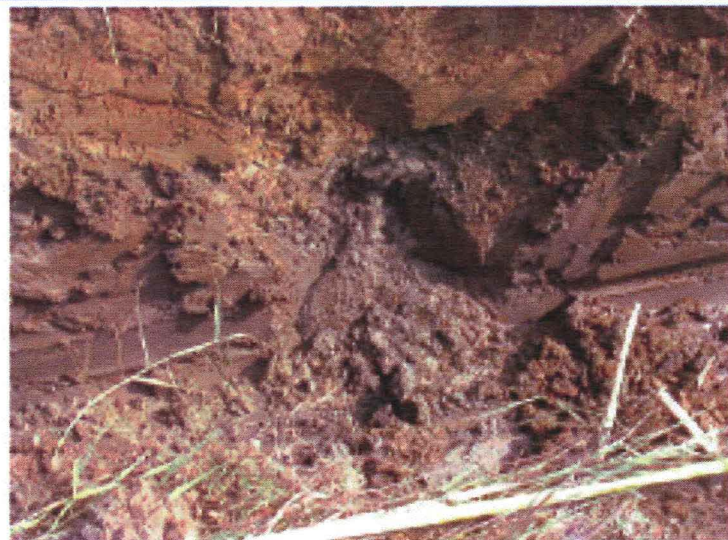
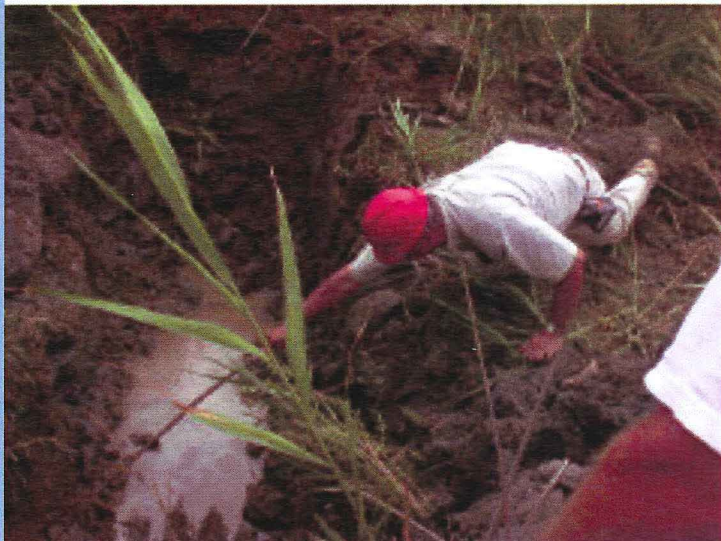
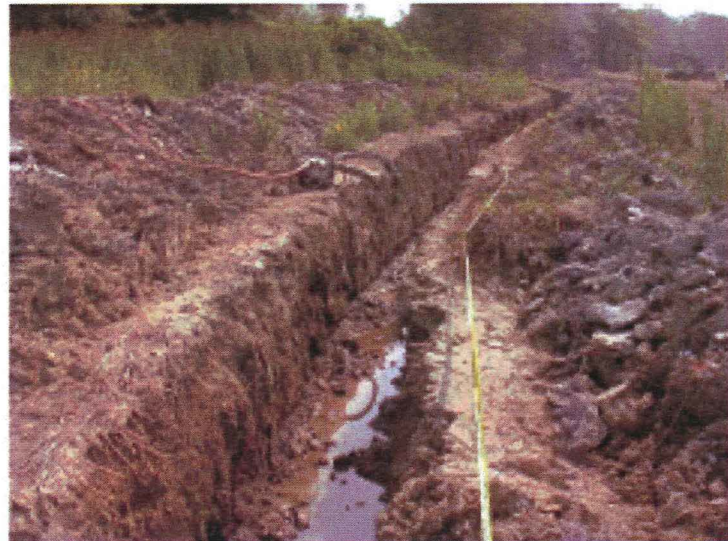
Trenching Activities

- **DNAPL found 6'–8' below ground surface in floodplain (2'–4' below stream bed)**
- **No evidence of 'top–down' migration from streambed**
- **Subsurface migration pathways: top of clay and till, sand seams and fractures (historically and at present)**
